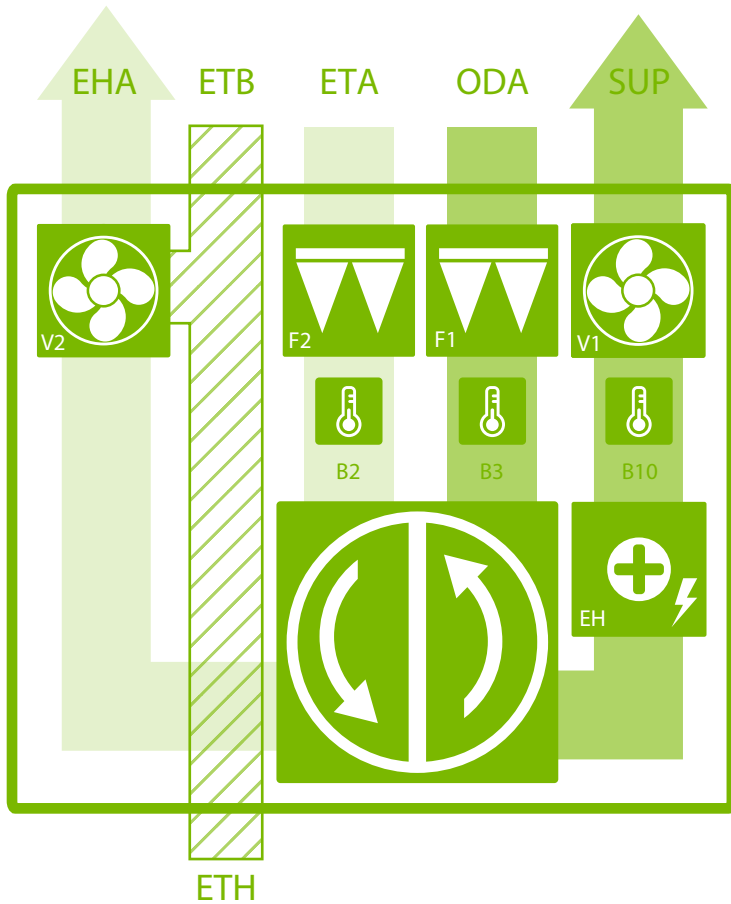
R1

INSPECTION SIDE
INSPEKSJONSSIDE

- ODA** Outdoor air / Inntak
- SUP** Supply air / Tilluft
- ETA** Extract air / Avtrekk
- EHA** Exhaust air / Avkast
- ETB** By-pass extraction without heat recovery / Bypass uten gjenvinning
- ETH** Kitchen hood connection (without heat recovery) / Tilkobling kjøkkenhette (uten varmegjenvinning)
-

Rotary heatexchanger / Roterende varmegjenvinner
-

Extract temperature sensor / Uttrekk temperatur sensr
- B2**
-

Outdoor temperature sensor / Utetemperaturføler
- B3**
-

Supply temperature sensor / Tilluftstemperatursensor
- B10**
-

Supply air fan / Tilluftsvifte
-

Extract air fan / Avtrekksvifte
- V1**
-

Extract air fan / Avtrekksvifte
- V2**
-

Electrical preheater / Elektrisk forvarmer
- EH1**
-

Electrical heater / Elektrisk varmebatteri
- EH**
-

Outdoor air filter / Friskluftfilter
- F1**
-

Extract air filter / Avtrekks filter
- F2**

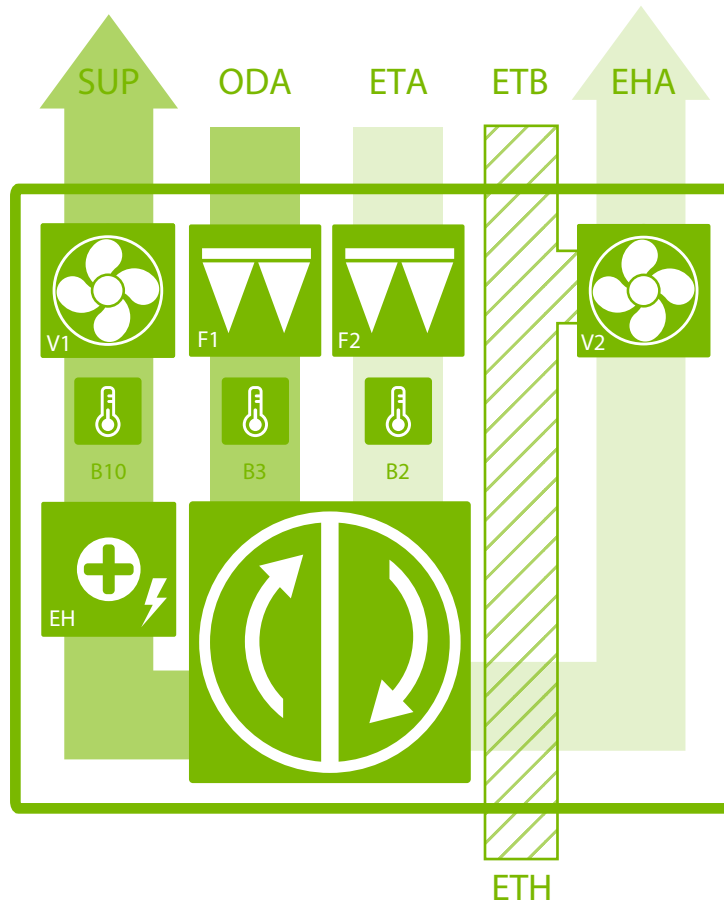
L1

INSPECTION SIDE
INSPEKSJONSSIDE
